# Test Report

Report No.:H202201241776-01EN

Sample Name: IEC60945 keyboard and mouse

Sample Model: K-TEK-M440-OTB-FN-BL-NV-EMC-DWP

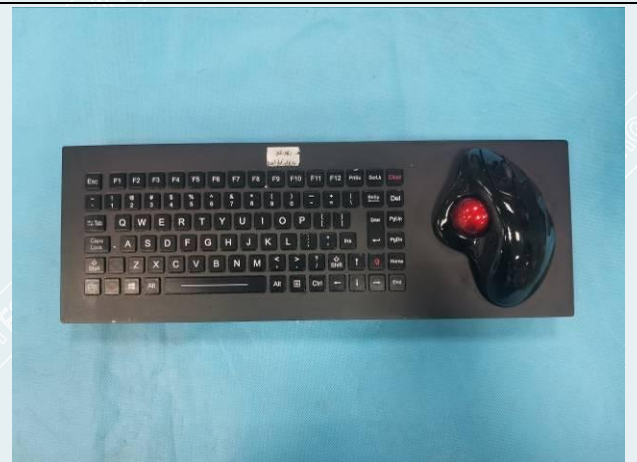
Fig.1-2 After test

Test No.	Test results		Conclusion
	High temperature storage	High temperature action	
H202201241776-01#	After the test, the sample function is normal.	During and after the test, the function of the sample is qualified.	Pass

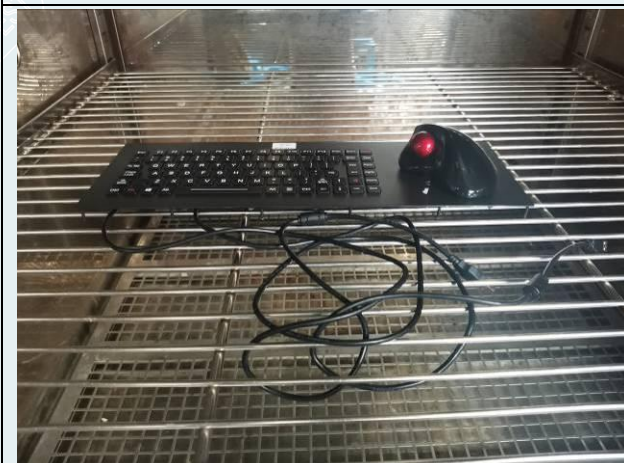
Fig.1-3 High temperature storage erection

1.1.2 High temperature storage: place the tested equipment in the environment of 70 °C for 16h, and the equipment is not powered on;

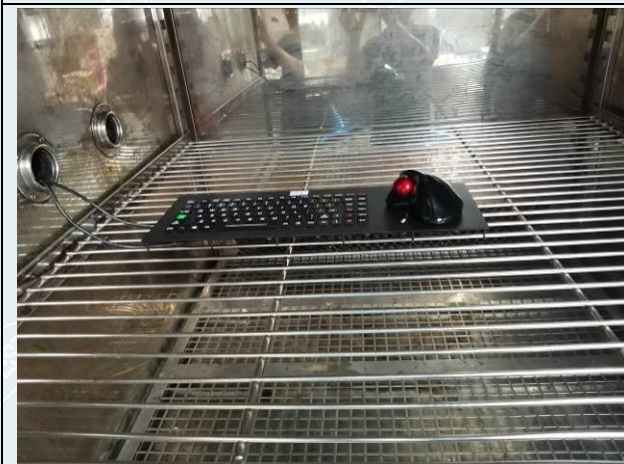
Fig.1-5 High temperature action erection

1.1.3 High temperature action: place the tested equipment at 55 °C for 16h, and conduct a performance inspection 16h and 55 °C.

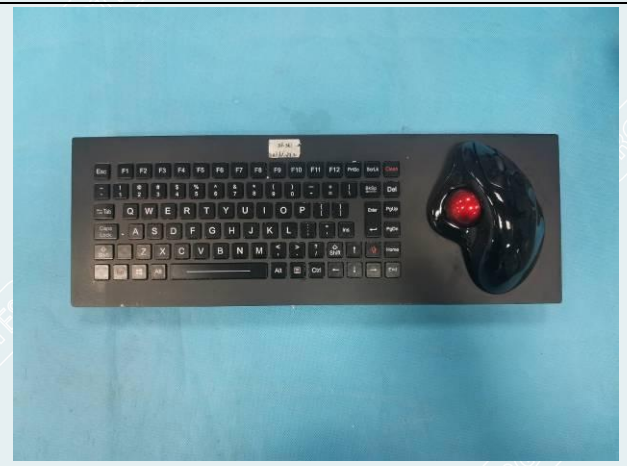
Fig.2-2 After test

Test No.	Damp heat test results	Conclusion
H202201241776-01#	After the test, the function of the sample is normal.	Pass

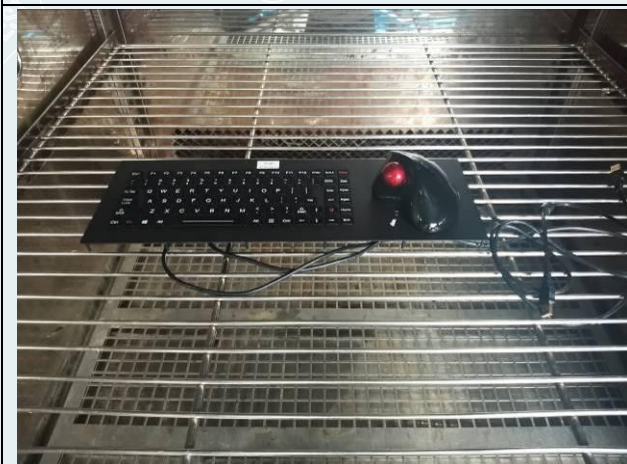
Fig.2-3 Test erection

Within 3-hour cycle, the temperature shall be increased to 40 °C and the relative humidity shall be increased to 93%, and the cycle shall be maintained for 16h;

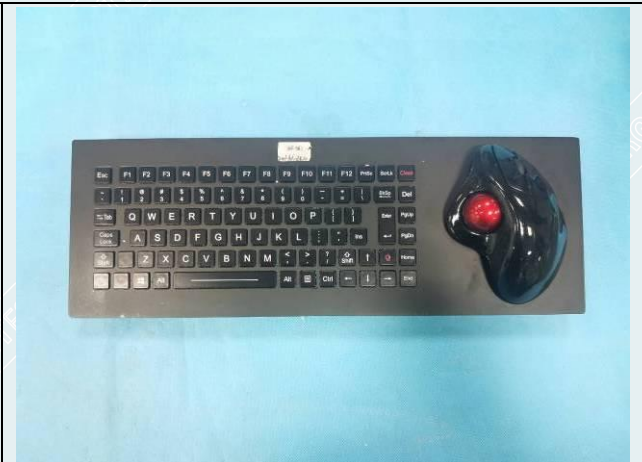
Fig.3-2 After test

Test No.	Test results		Conclusion
	Low temperature storage	Low temperature action	
H202201241776-01#	After the test, the sample function is normal.	During and after the test, the function of the sample is qualified.	Pass

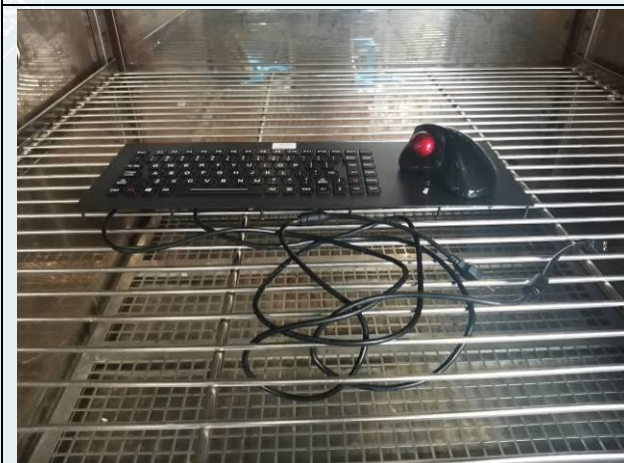
Fig.3-3 Low temperature storage erection

3.1.2 Low temperature storage: place the tested equipment in - 30 °C environment for 16h, and the equipment is not powered on;

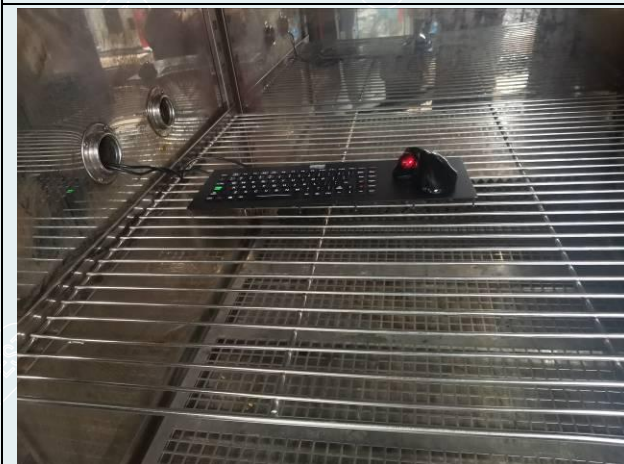
Fig.3-5 Low temperature action erection

3.1.3 Low temperature action: place the tested equipment at - 20 °C for 16h, the equipment under test shall be subject to one-time energy inspection in this environment.

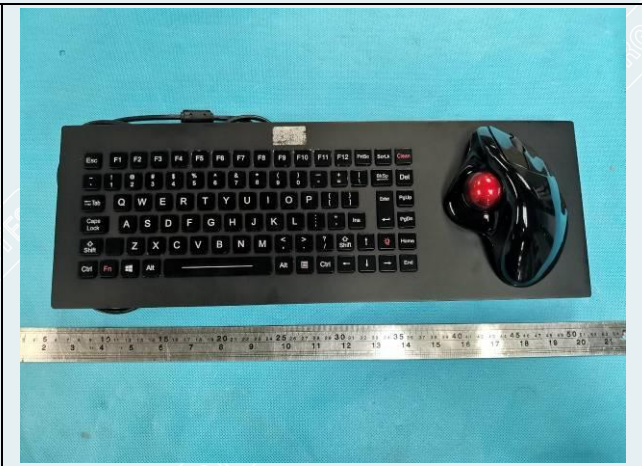
Fig.4-2 After test

H202201241776-01#	After the test, the function of the sample is normal, and the metal parts are free from improper damage and corrosion.	Pass
-------------------	--	------

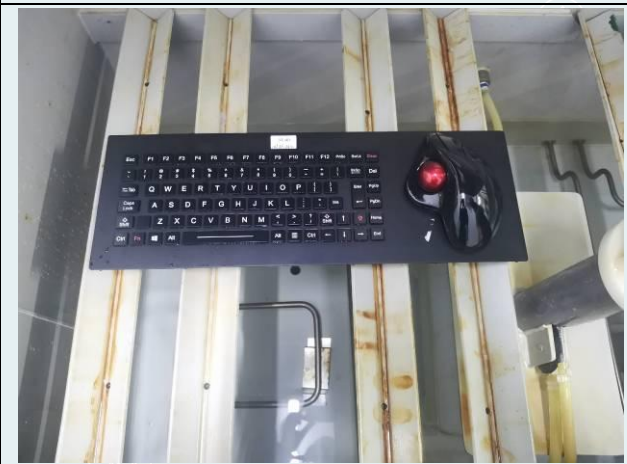
Fig.4-3 Salt spray erection

4.1.2 The tested equipment is placed in the salt spray box and sprayed for 2h. The configured concentration of NaCl salt solution is  $(5 \pm 1)\%$  and the salt spray deposition in the test box is  $(1.0 \sim 2.0) \text{ mL} / (80\text{cm})^2 \cdot \text{h}$ , the pH value of the salt solution is  $(6.5 \sim 7.2)$  under the temperature condition of  $(35 \pm 2) \text{ }^\circ\text{C}$ ;

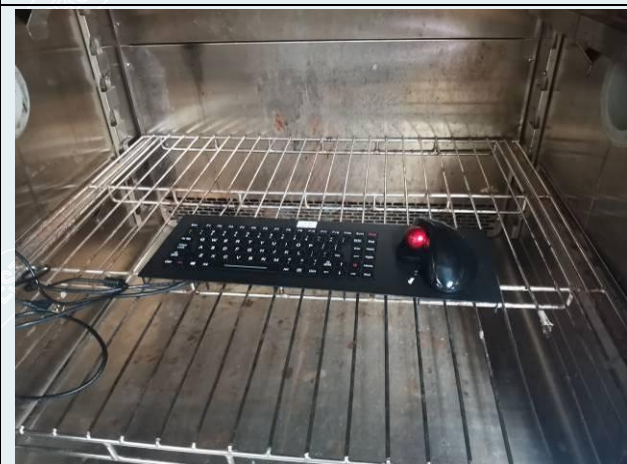
Fig.4-5 Temperature treatment erection

4.1.3 After the salt spray test, the tested equipment shall be placed in the environment of  $40 \text{ }^\circ\text{C}$  and  $90\% \sim 95\%$  relative humidity for 7 days.

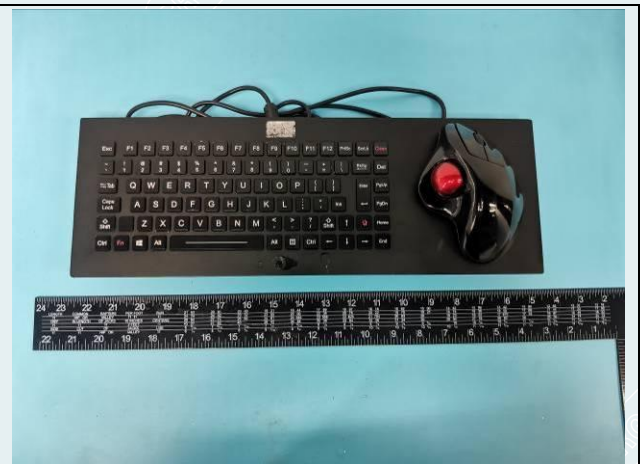
Fig.5-2 After test

Test No.	Test results		Conclusion
	Resonance point search	Standing frequency test	
H202201241776-01#	No resonance points were found in the three mutually perpendicular directions.	In the 30Hz vibration test, the function of the sample is qualified, and the function of the sample is normal after the test.	Pass

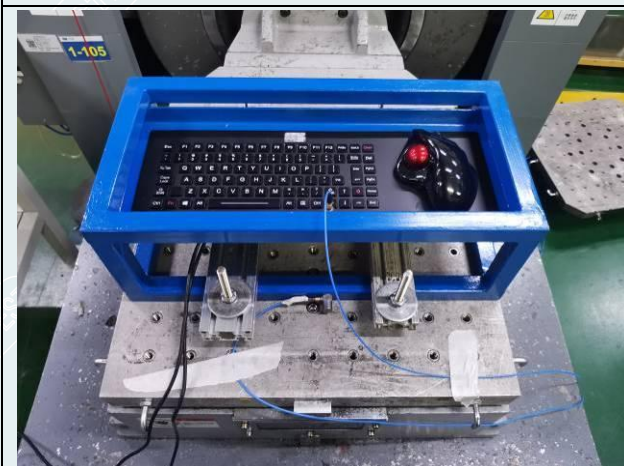
Fig.5-3 Resonance point search (X)

2Hz to 5Hz ~ 13.2Hz, amplitude  $\pm 1$ mm, 13.2Hz ~ 100Hz, acceleration  $7m / S^2$ , frequency sweep rate 0.5oct/min;

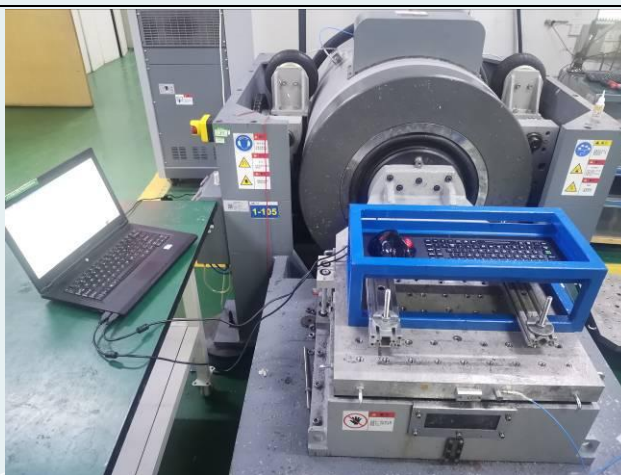
Fig.5-9 Standing frequency test (X)

- a) Vibrate for 2h at the resonance moving point or 30Hz, and the vibration directions are three mutually perpendicular directions;
- b) During each vibration test, at least one performance inspection shall be carried out in three mutually perpendicular directions.

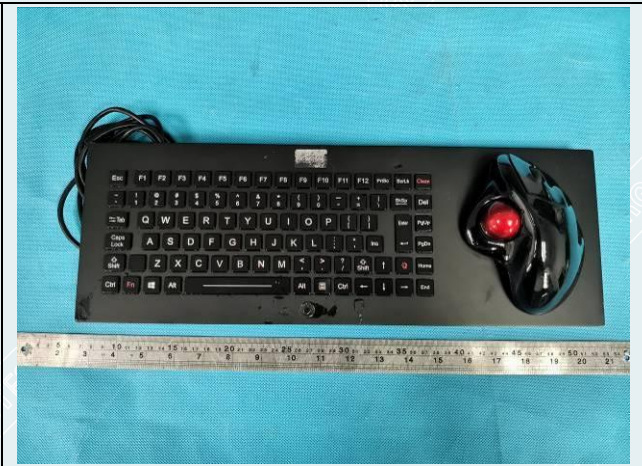
Fig.6-2 After test

Test No.	Rain and spray(IPX6) test results	Conclusion
H202201241776-01#	After the test, the sample function is normal.	Pass

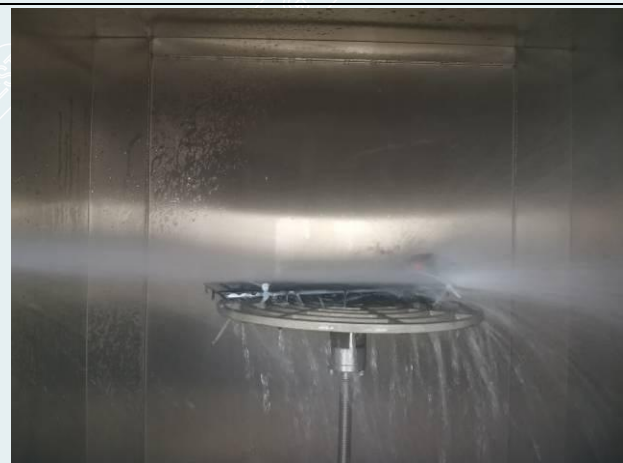
Fig.6-3 Test erection

- 6.1.1 Test basis: Section 8.8 of IEC60945:2002;
- 6.1.2 Spray the tested equipment with the water flow from a standard test nozzle;
- 6.1.3 Test method:
- 1) Inner diameter of nozzle: 12.5mm;
  - 2) Water flow:  $(100 \pm 5)$  L / min;
  - 3) Water pressure: adjust to the specified transmission speed;
  - 4) The center of the main water flow: a circle with a diameter of about 120mm at a distance of 2.5m from the nozzle;
  - 5) Test duration: 30min;
  - 6) Distance from nozzle to equipment surface: About 3m.
