Test Report

Product name: Silicone keyboard

Model Specifications: K-TEK-M275TP-FN-BL-NV-EMC-151B

1. Humidity

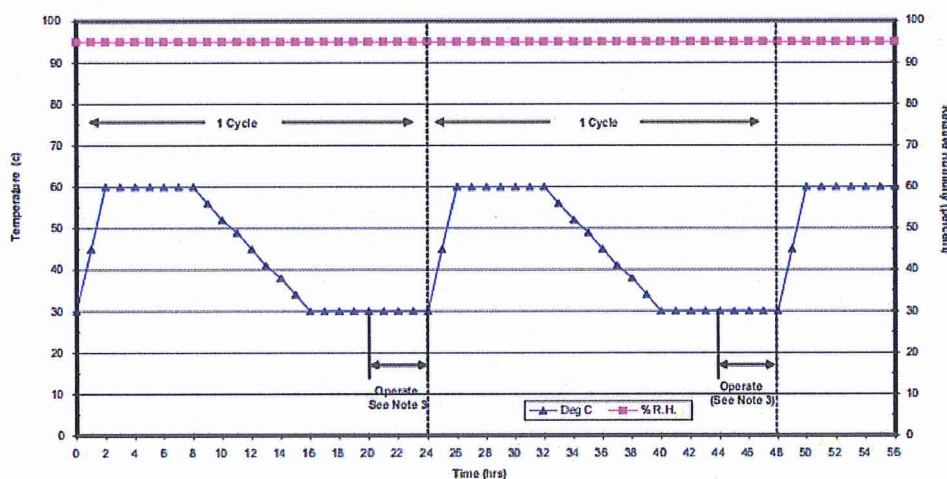
- 1) Test temperature: 30°C~60°C;
 - 2) Test humidity: 95%RH;
 - 3) Test time: 24h is a cycle, 10 cycles, a total of 240h;
 - 4) Sample status in the test: according to the standard requirements, the performance of the sample is tested in the 5th and 10th cycles, and the sample does not work in other cycles;
- c) Post-test detection: under standard atmospheric conditions, the appearance inspection and performance inspection of the tested products are carried out.

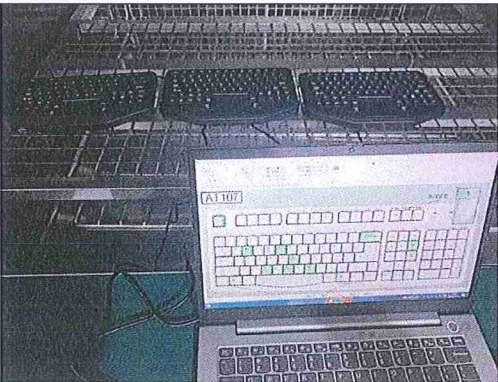
Figure 3 Performance test	Figure 4 Partial test curve

After the test, there was no obvious damage to the appearance and structure of the sample. In the 5th and 10th cycle, the performance test of the sample was normal and qualified.
